FACILITY STATUS CHANGE FORM

Date Submitted: June 12, 2014 Originator: Chris Strand Phone: 554-2720	Area: 300 Area Facility ID: 320 & 320BA Action Memorandum: Action Memorandum #3	Control #: D4-300-059-1
--	---	-----------------------------------

Attachment 1: Facility Information

Attachment 2: Project Photographs

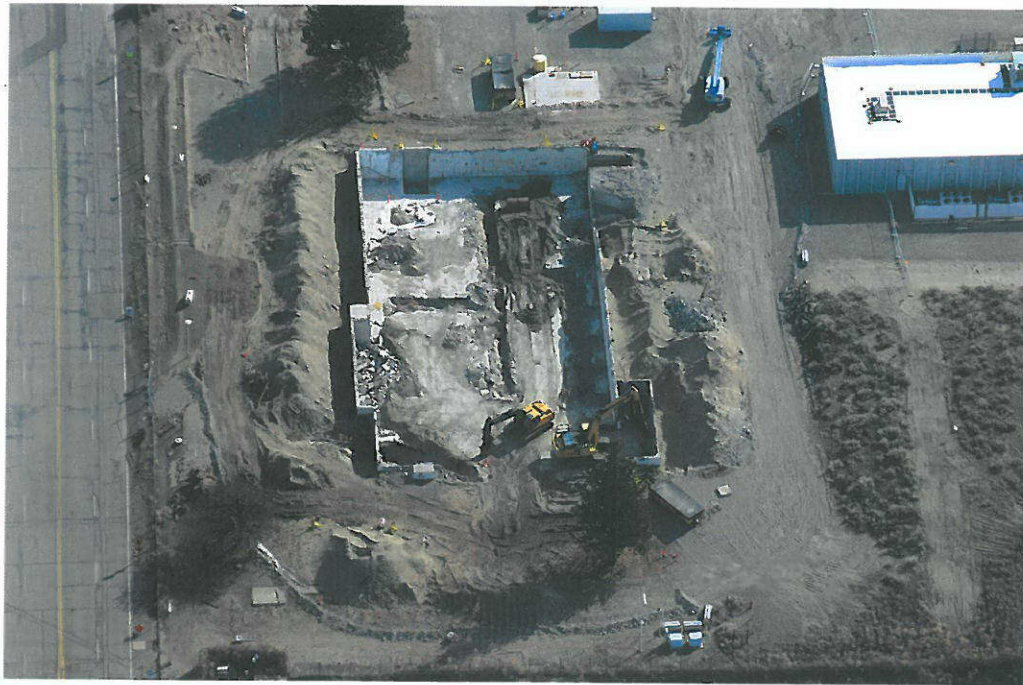
Photo 3. Looking east at the 320 Building basement and 320BA Slab on March 8, 2012.

The 320BA slab and the southeast corner of the 320 building were demolished and backfilled with clean material. The 320 basement walls and floor remain. Portions of the 320 concrete basement floor were removed to access process sewer piping. A Civil survey and GPERS survey are included as attachments 3 and 4, respectively. No GPERS was conducted after removal of the 320BA slab and southeast corner of the 320 Building foundation. Soils were evaluated before backfill, no anomalies noted.

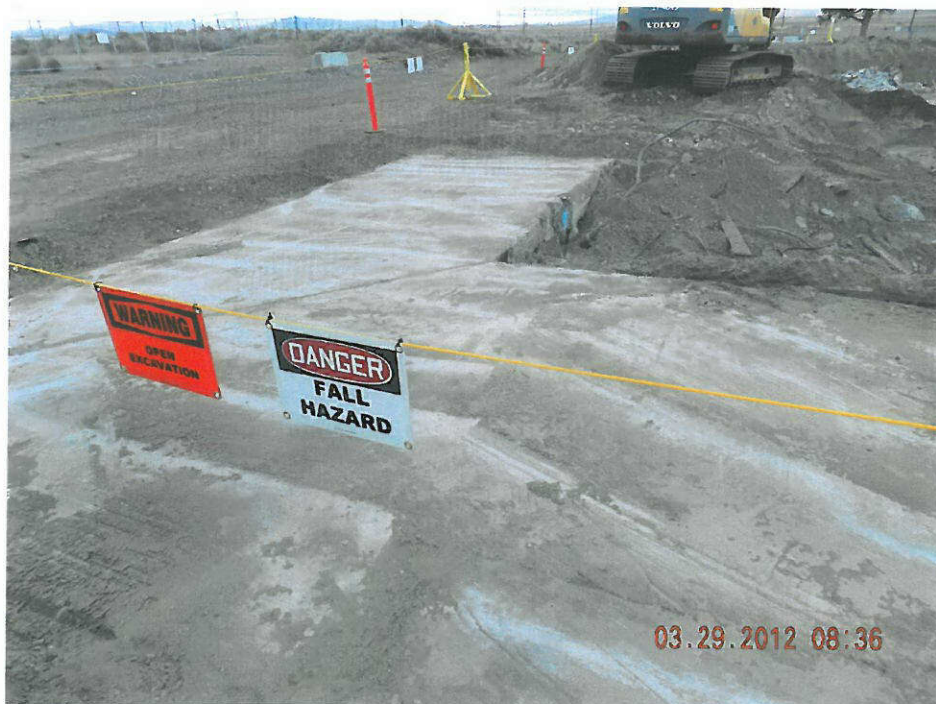
Removal of the 320BA slab and a portion of the southeast corner of the 320 Building foundation were originally deferred because of interference by an active 13.8 KV underground electrical line. In 2014 this line was permanently de-energized, which eliminated the interference and allowed removal of the deferred portions of both facilities. The 320BA slab and southeast corner of the 320 foundation were demolished, loaded out, and backfilled in May 2014.

Photo 4. Photo of the southwest corner of the 320 Building slab left due to utility interference.

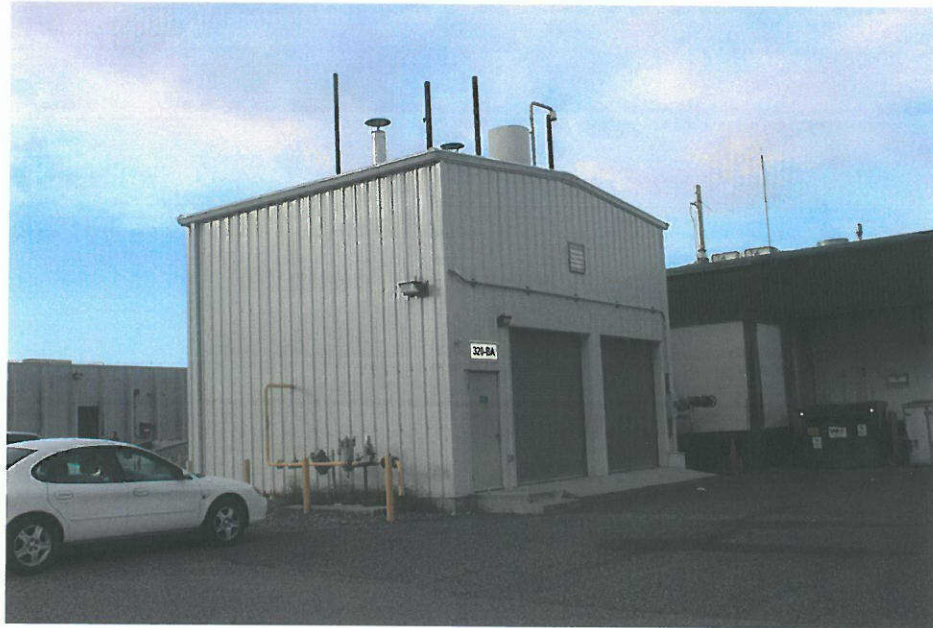
Photo 5. Looking southwest at 320BA on February 7, 2011.

The 320BA Boiler Annex was located adjacent to the southeast corner of the 320 Building. Constructed in 1997, the 320BA boiler annex was a pre-engineered metal building on a concrete slab that measured approximately 24' x 30'. 320BA housed a gas fired package boiler system to provide heat for 330. The boiler annex was electrically heated with natural gas, water and sewer connections. Inside floor drains and intermittent blowdown separators drained to a sump that was tied to the process sewer.

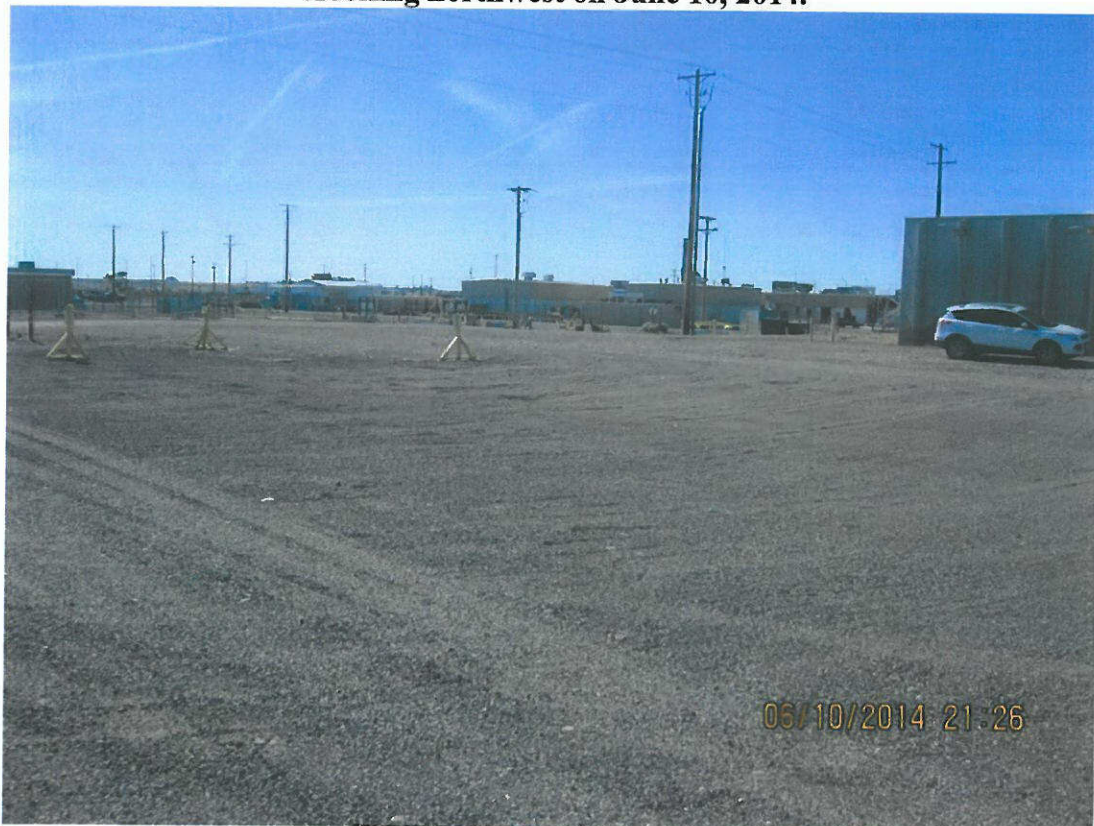
**Photo 8. 320 Foundation & 320BA slab after backfill.
Looking northwest on June 10, 2014.**

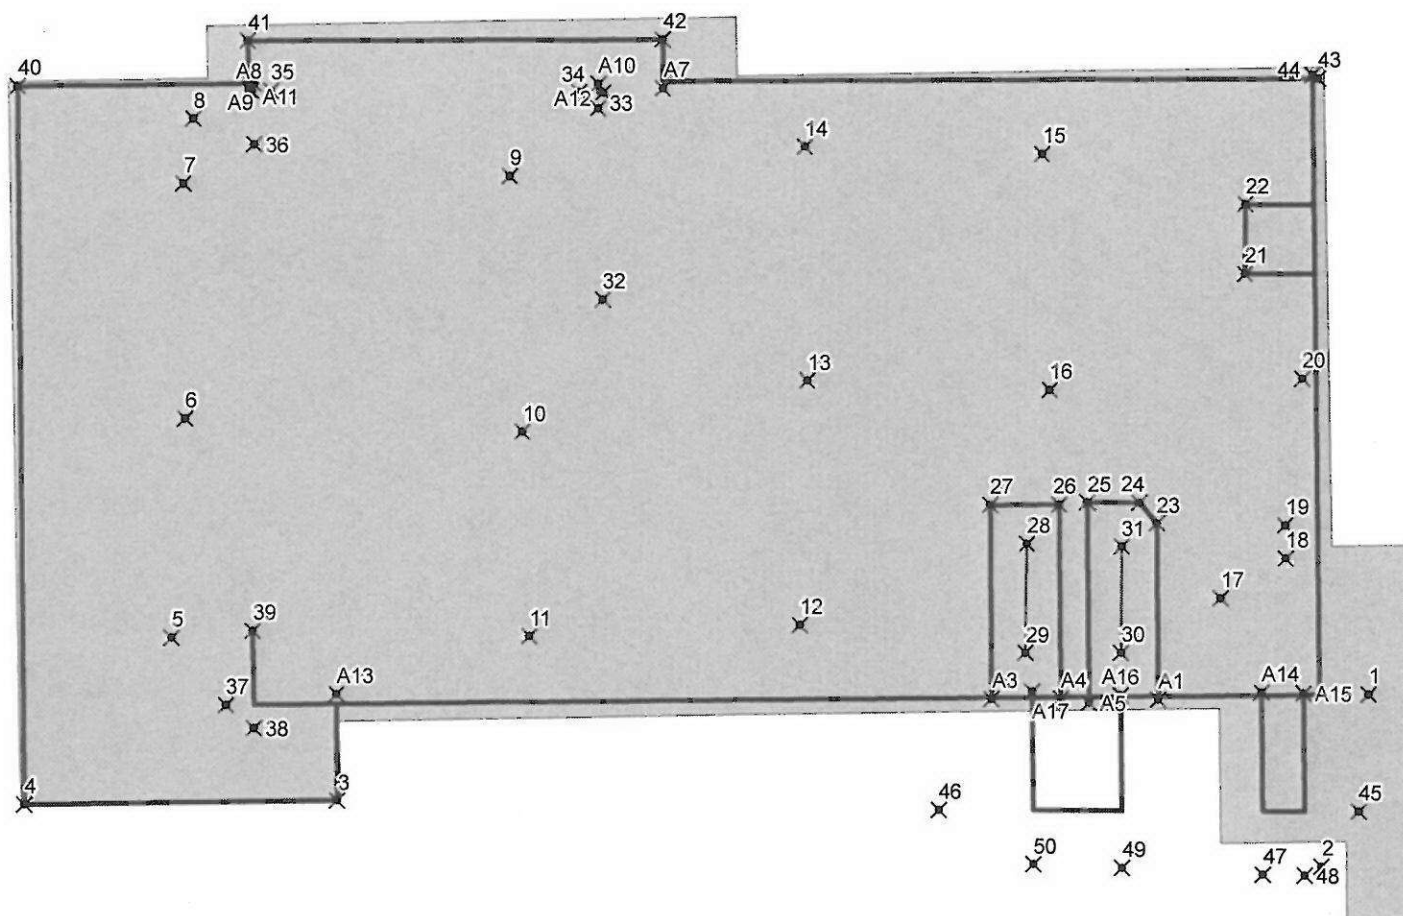
Attachment 3: Civil Survey.

- × See GPS Survey Report for Point Details
- 320 Building Foundation and Walls
- Building Location Pre-Demolition

GPS Post-Demo Survey for the 320 Building Foundation and Walls (Remaining)

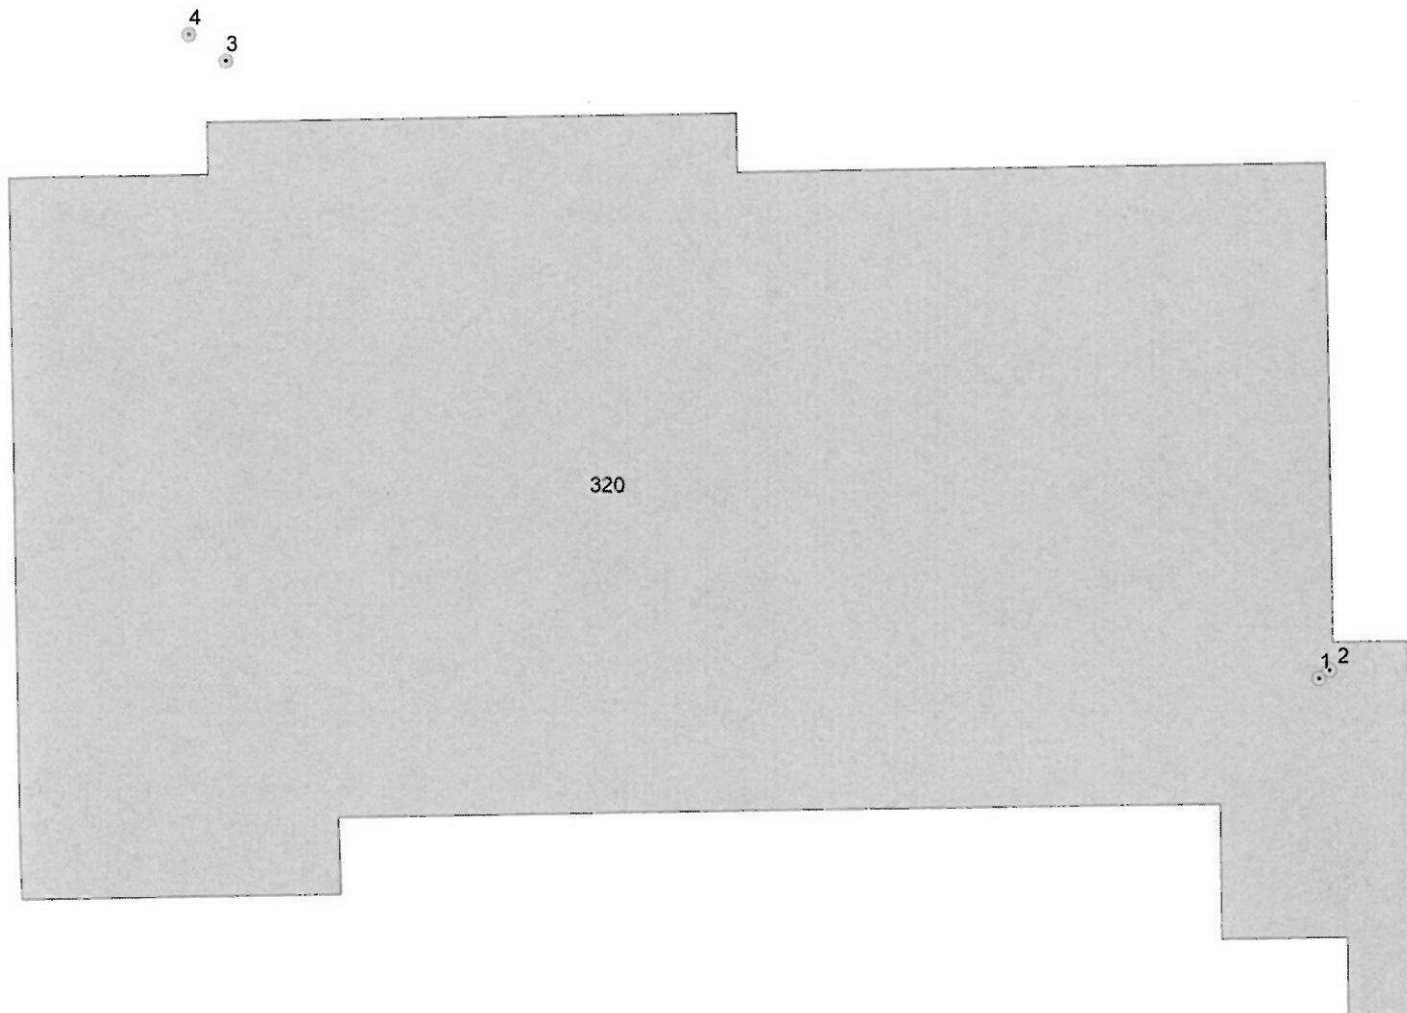
Name	Feat_Code	Northing	Easting	Elevation
1	Fire Water -6in Steel	115491.31	593834.40	120.759
2	Process Sewer - 4in Steel	115491.65	593834.81	120.536
3	Sanitary Sewer - Clay Pipe	115516.38	593789.44	120.917
4	Process Sewer - 6in Steel	115517.45	593787.92	120.791

GPS Post-Demo Survey for the 320 Building Cut Pipe Locations

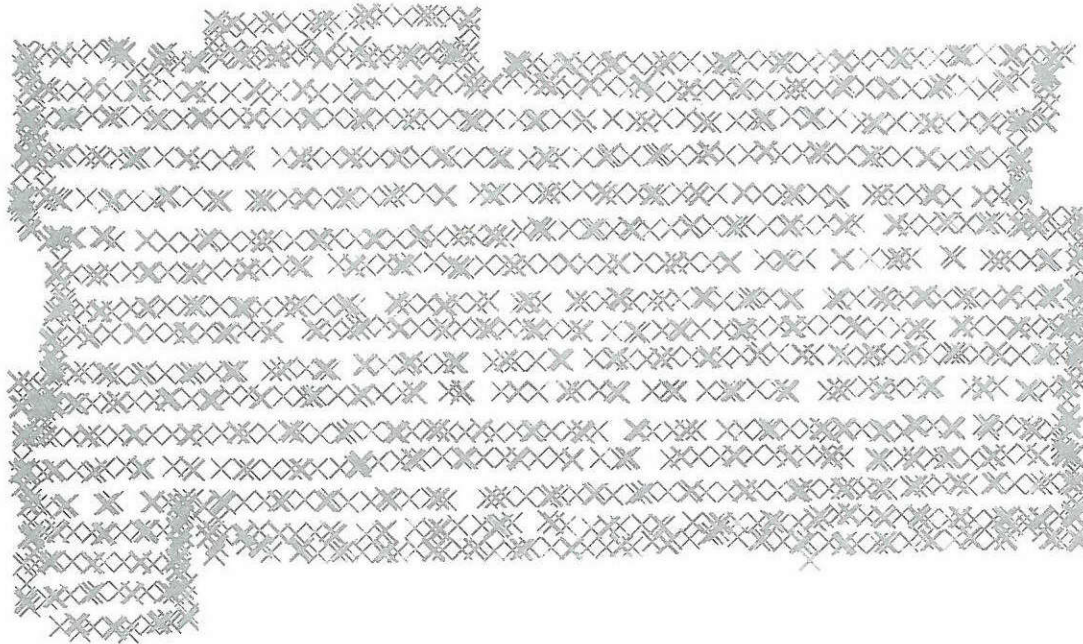
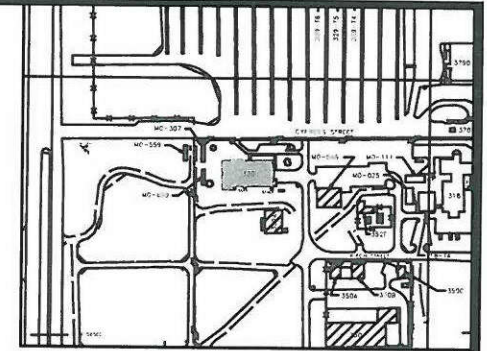
Attachment 4: GPERS Survey.

Coverage File: D4304
Number of Data Pnts: 4009
Type of Survey: gamma
Max GCPM: 2253
Avg Bkg CPM: 1306
Survey Date: 10/31/2011
Area Surveyed: 1300 m²
Project File: ESRFRM110207
Pdf File: ESRFRM110207C

300 D4 Field Remediation 300/320 Slab GPERS Radiological Survey Gamma Track Map
